Compatibility of Material and Electronic Equipment With Hydrogen Peroxide and Chlorine Dioxide Fumigation

ASSESSMENT AND EVALUATION REPORT

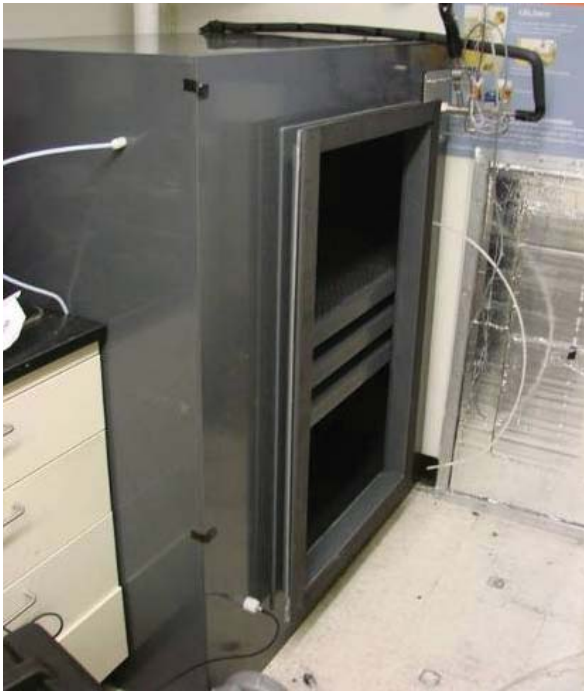
Figure 1-2. Photograph of the MEC test chamber.

chamber served as the isolation chamber for the ClO_2 -exposed material/equipment. Figure 1-1 shows the dimensions of the MEC chamber; a photograph of the MEC test chamber is shown in Figure 1-2. The three computer installation setup used for ClO_2 fumigations can be seen in Figure 1-1. For the H_2O_2 fumigations, only two computers were inside the chamber at a time, one open (OFF power; see Figure 1-3) and one closed (ON power).

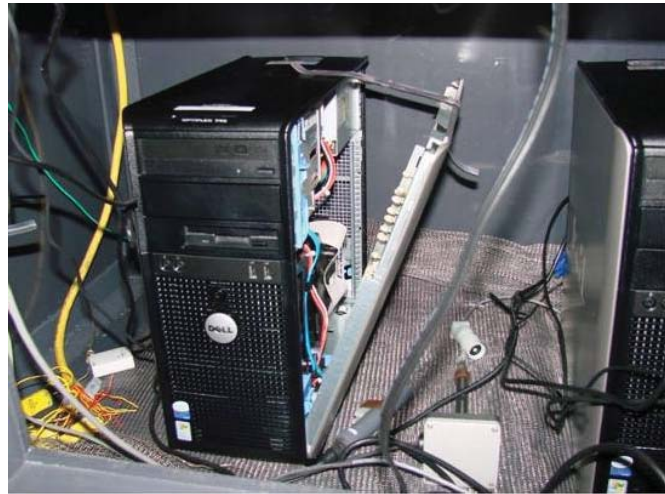
Figure 1-3. Open computer in HPV MEC chamber.

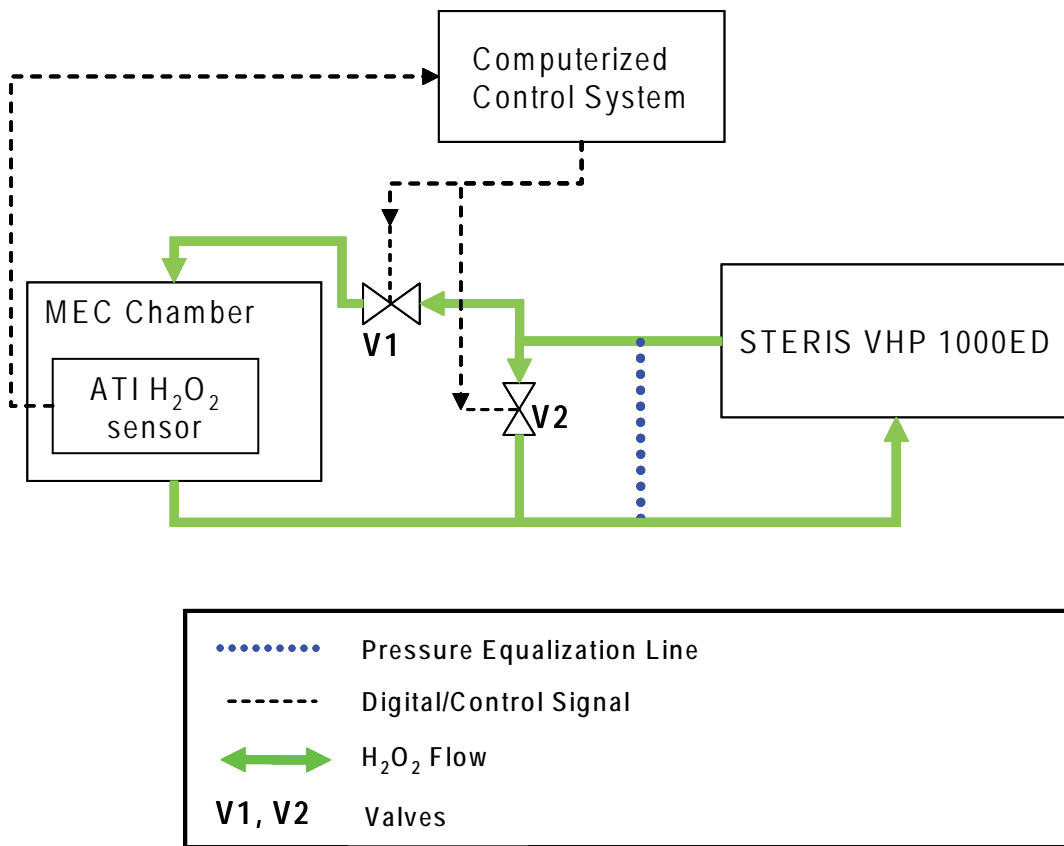
Figure 2-1. External STERIS control schematic

The STERIS VHP® 1000ED generator, loaded with a 17.5 percent H₂O₂ cartridge, was connected to the MEC through the control system shown in Figure 2-1. The monitoring methods (H₂O₂ detection methods) employed were listed in Table 2-1. The computerized control system had a user-defined concentration setpoint of 250 ppm.

The STERIS VHP® 1000ED was programmed with the fumigation cycle shown in Table 2-3. When the control system received data from the Analytical Technology sensor that the H₂O₂ concentration was below the setpoint, valve V1 would be opened and valve V2 would be closed. As the concentration climbed above the setpoint, valve V1 would close and V2 would open, returning the H₂O₂ vapor back to the STERIS unit.

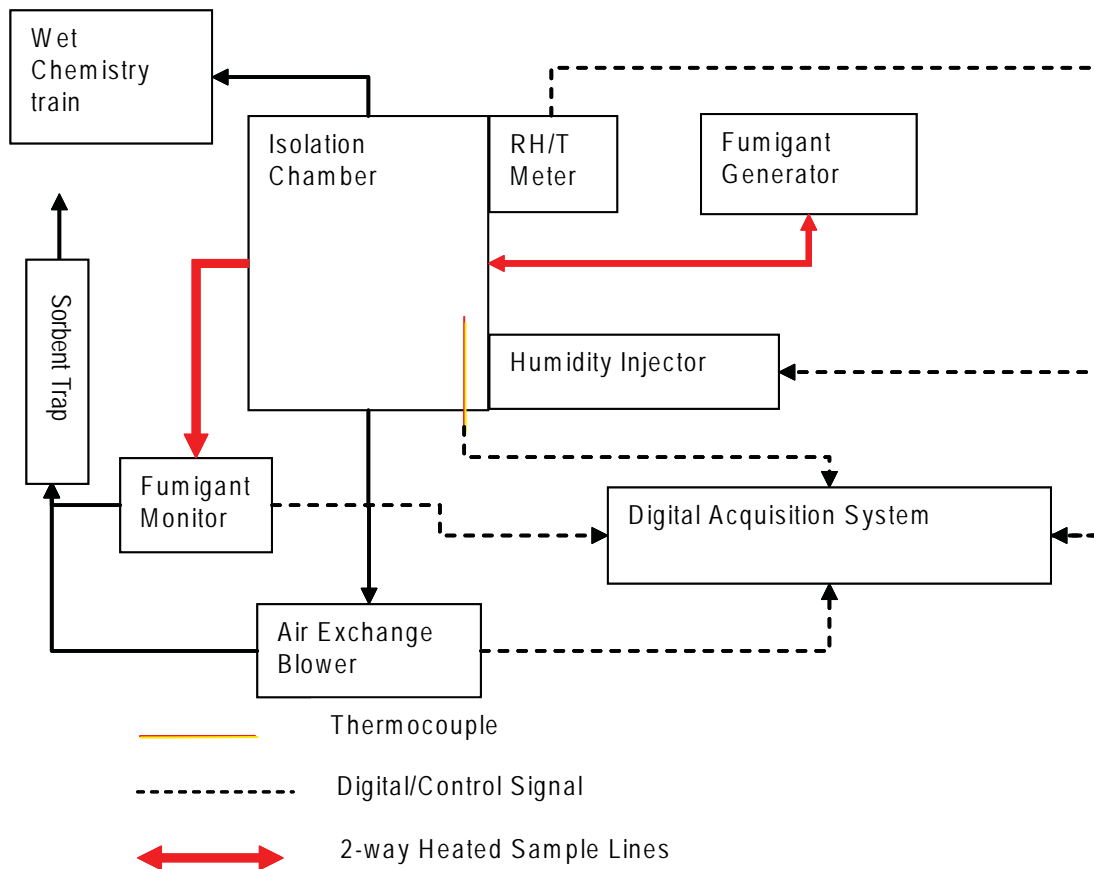
Figure 2-2. Experimental setup of the MEC test chambers

The ClO₂ fumigations were performed at both 3000 ppmv and 750 ppmv. Figure 2-2 shows the generic schematic for the fumigation experimental set-up. The ClO₂ concentration in the test chamber was directly controlled with the GMP. The secondary fumigant monitor was the EMS. The wet chemistry samples, analyzed by modified Standard Method SM 4500-E, were taken every 30 minutes during the decontamination phase to confirm the concentration of ClO₂ in the MEC test chamber. The RH of the MEC chamber was controlled by a feedback loop with LabVIEW and a Vaisala temperature/RH (T/RH) sensor. When the RH reading fell below the desired setpoint, the data acquisition system (DAS) injected hot humid air into the MEC chamber.

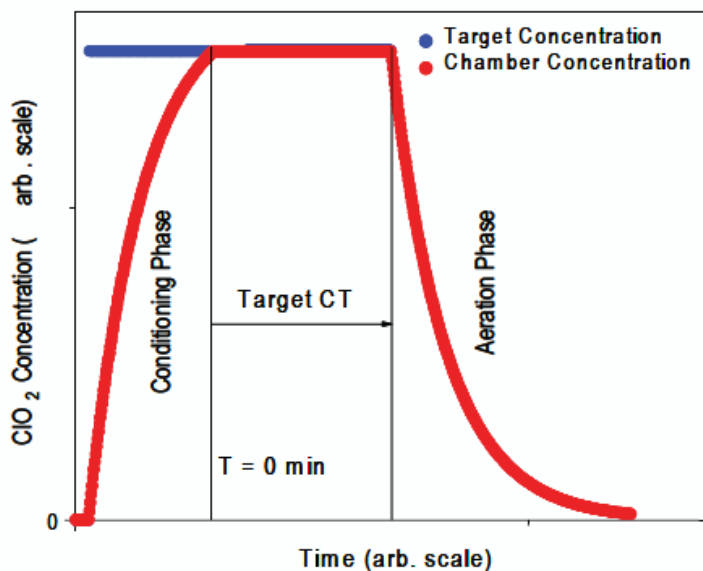
The phases of a fumigation event are graphically depicted in Figure 2-3. The times and demand rates for each phase shown are presented for illustration purposes only.

Figure 2-3. Material and equipment exposure time sequence

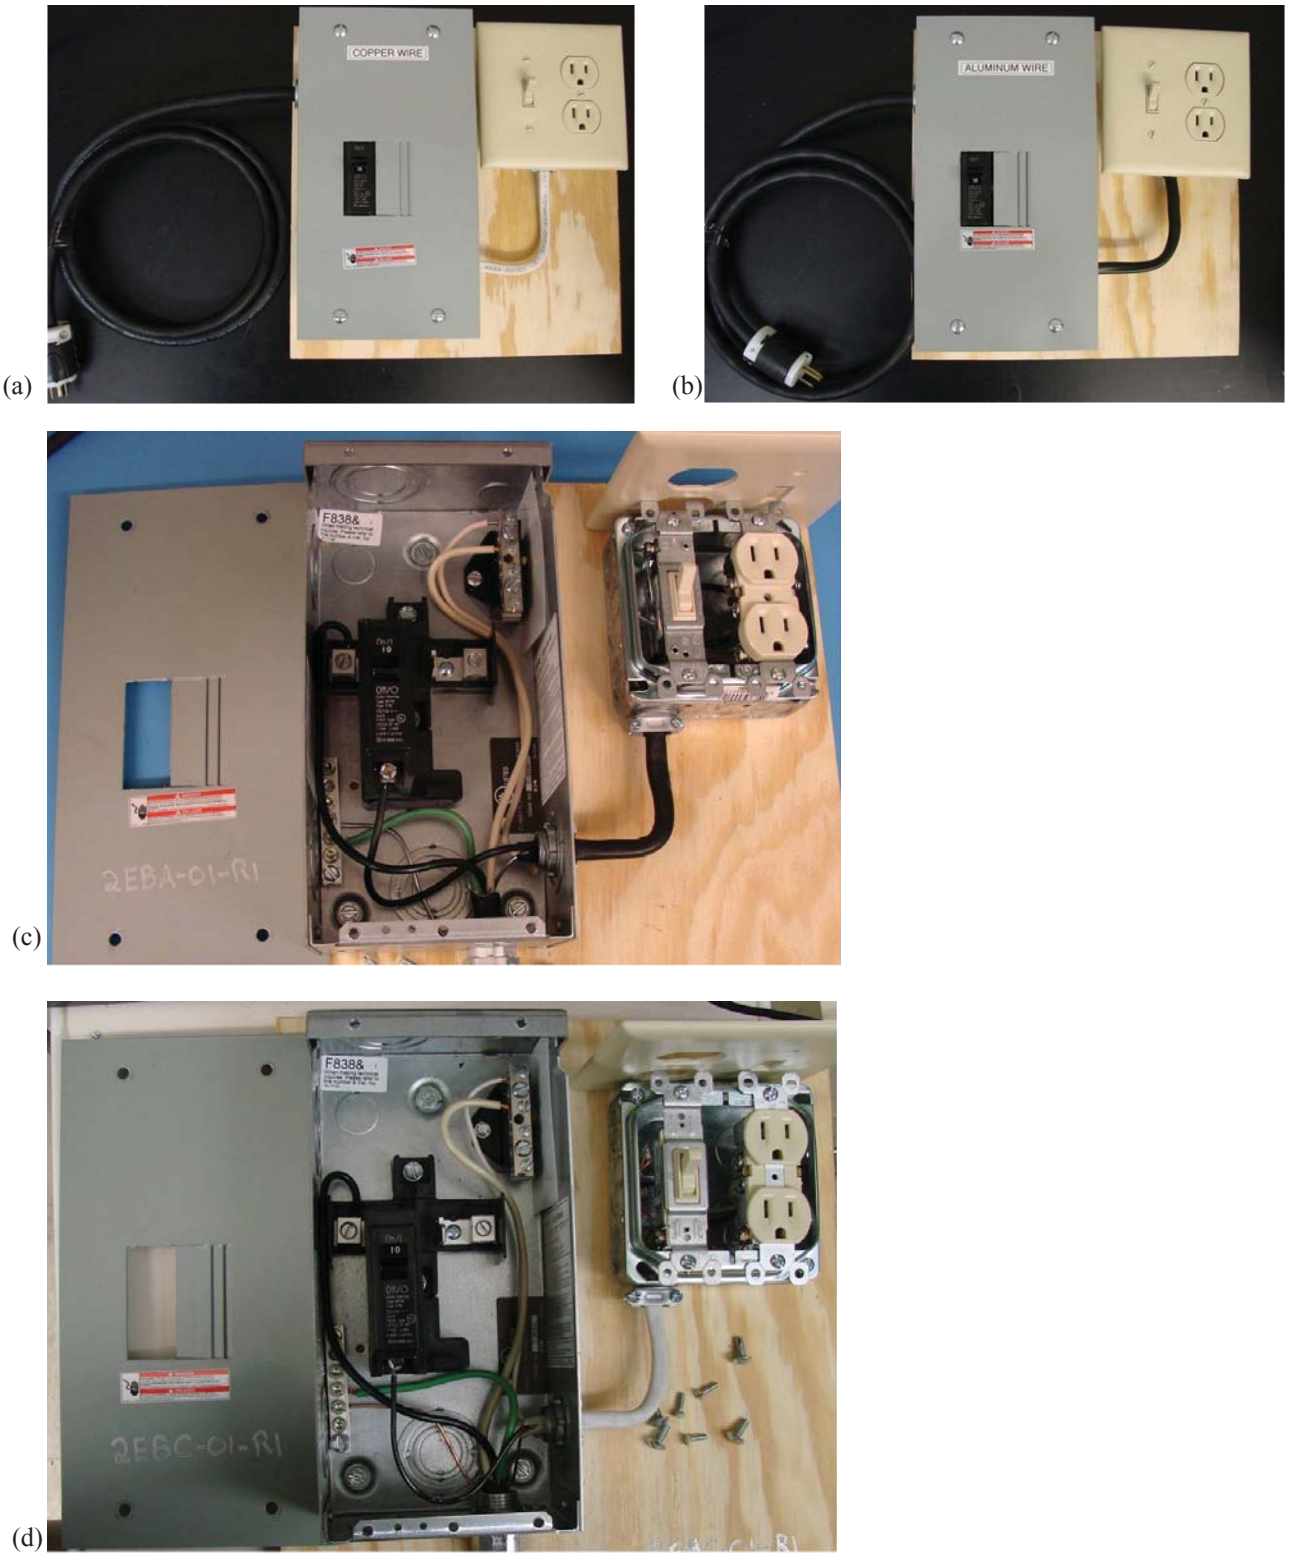
Figure 3-3. (a, c) Copper services, (b, d) aluminum services, and (e) circuit breaker used in the compatibility testing.

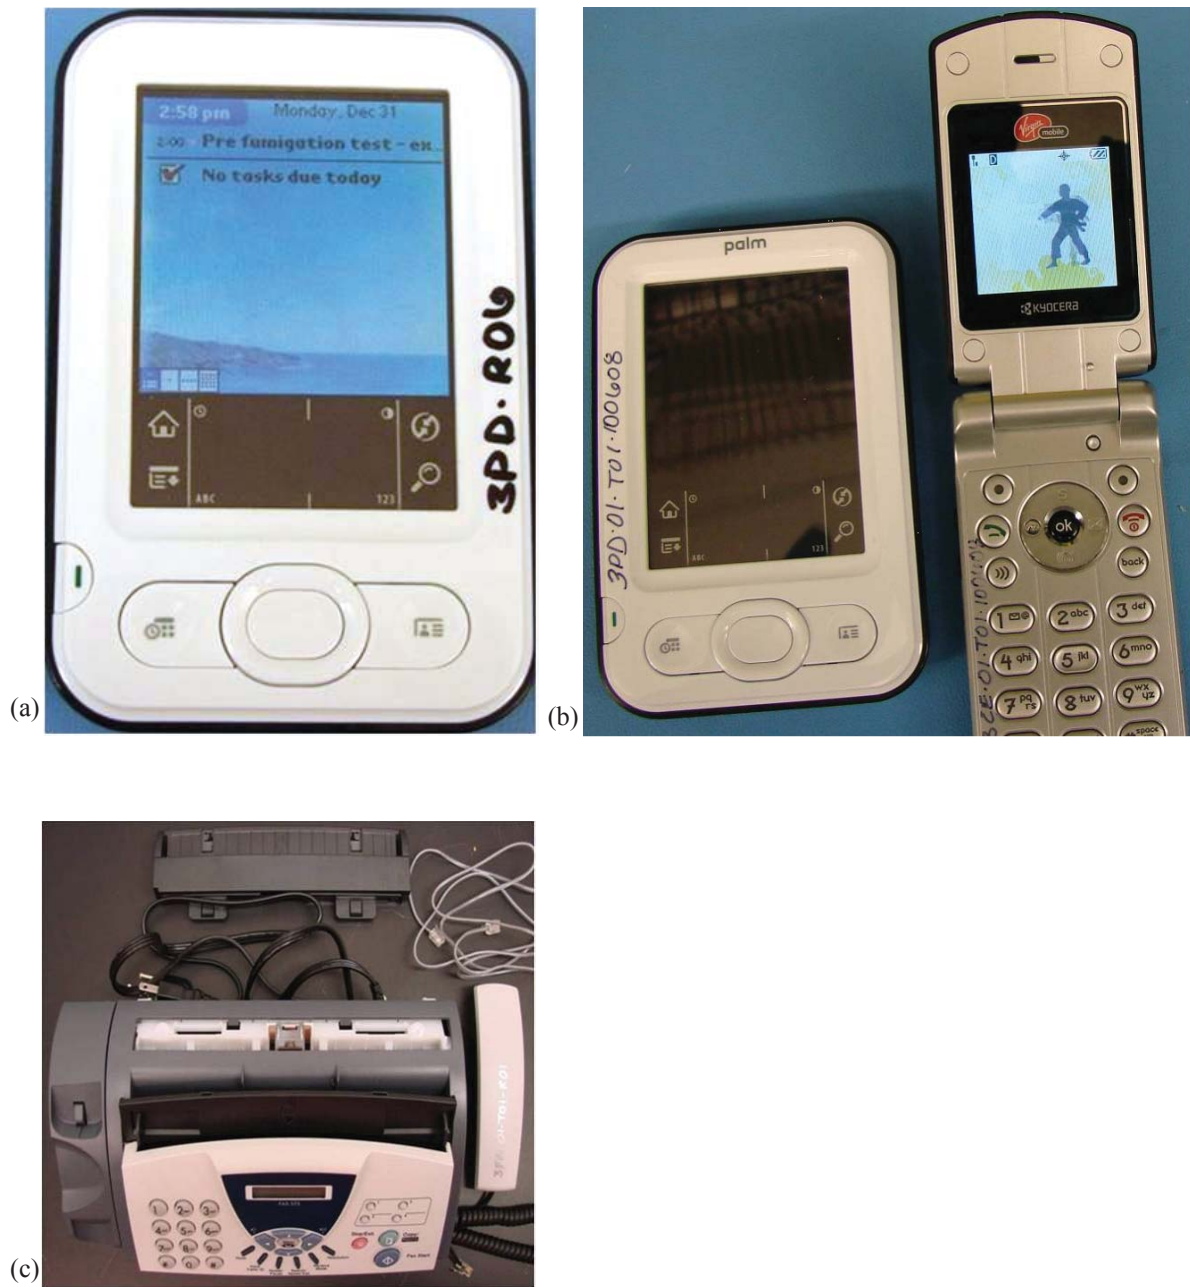
Figure 3-6. (a) PDA, (b) cell phone, and (c) fax machine used in the compatibility testing.

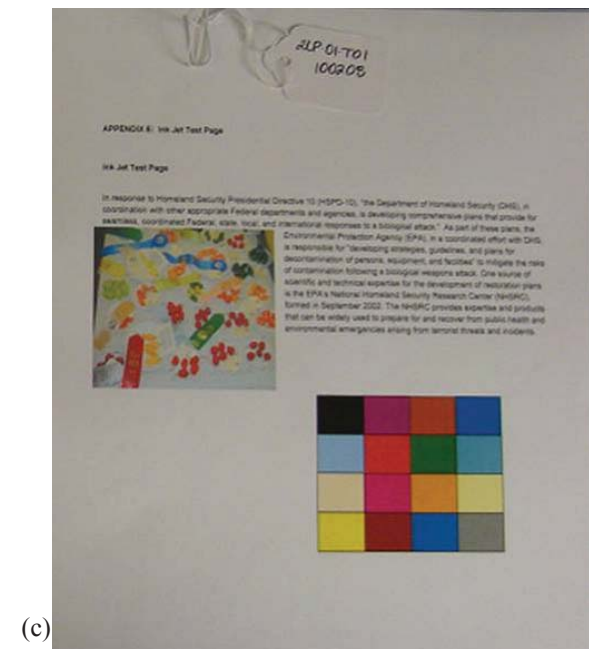
Figure 4-1. Inkjet printed paper (a) before and (b) 12 months after HPV fumigation (R01). Laser printed paper (c) before and (d) 12 months after HPV fumigation at higher initial RH (R02). Glossy 5”x 6” color photographs (e) before and (f) 12 months after HPV fumigation at higher initial RH (R02).

These results are typical for all six fumigation conditions studied with both BioQuell HPV and STERIS VHP fumigation technologies. The printed paper and photographs for each fumigation condition remained visibly unchanged throughout the 12-month post fumigation observation period. Color pigments do not appear to be adversely affected by exposure to vaporized H₂O₂ at either high or low concentrations or RH levels. In addition, extending the duration of the H₂O₂ exposure by 1.5x (test run R04) had no impact on these Category 2 materials.

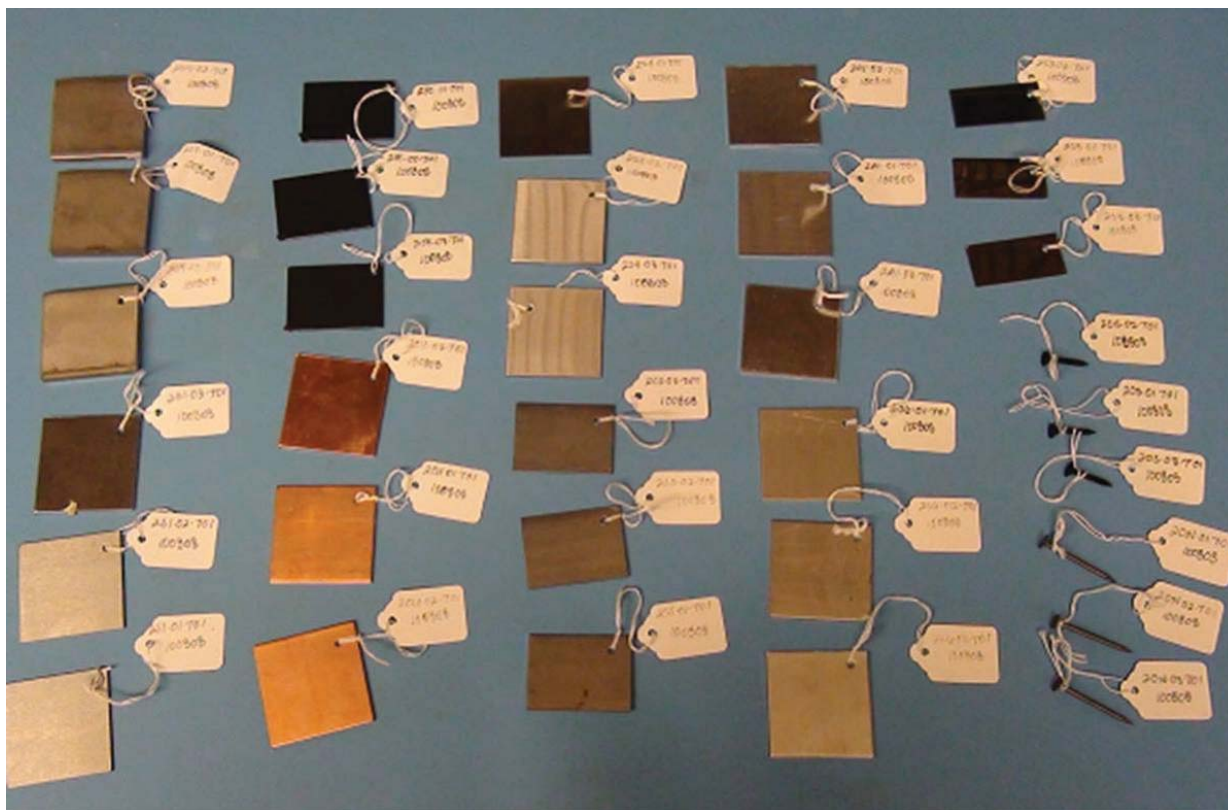
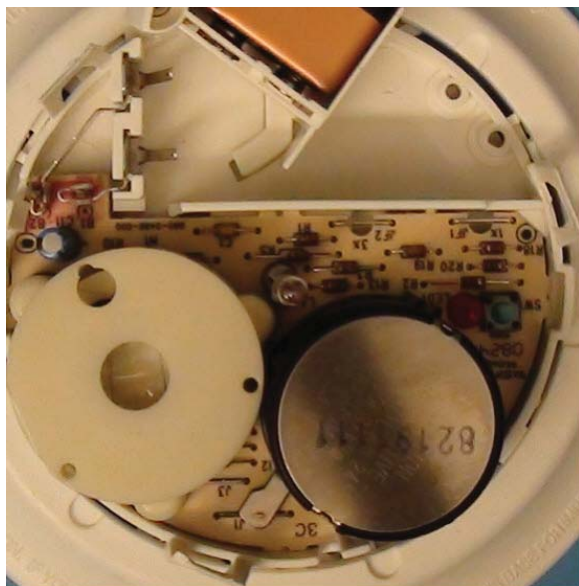
Figure 4-2. (a) Category 2 metals, (b) Inside of a smoke detector, and (c) exposed wire of stranded wire 12 months after H_2O_2 fumigation.

Vaporized H_2O_2 exposure showed no caustic effects on the other Category 2 materials tested under any of the test conditions. Figure 4-2(a) shows that each set of metals remained tarnish free, with no signs of rust or corrosion. Each exposed smoke detector remained fully operational throughout the year after exposure;

the battery terminals, resistors, and other components showed no signs of physical damage as seen in Figure 4-2 (b). Figure 4-2 (c) shows that the exposed stranded wires remained tarnish free for 12 months after exposure. These results were typical for each of the six fumigation conditions.

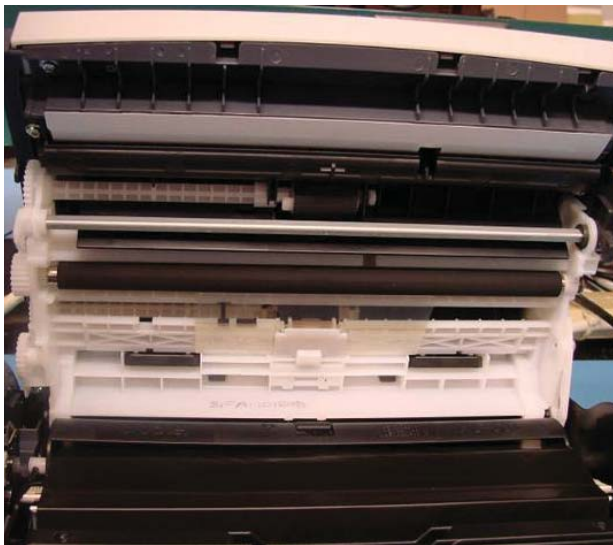
Figure 4-3. Internal view of fax machine 12 months after HPV exposure.

There were no signs of damage to any of the mechanical parts of the fax machine, and the same level of operation was maintained throughout the year.

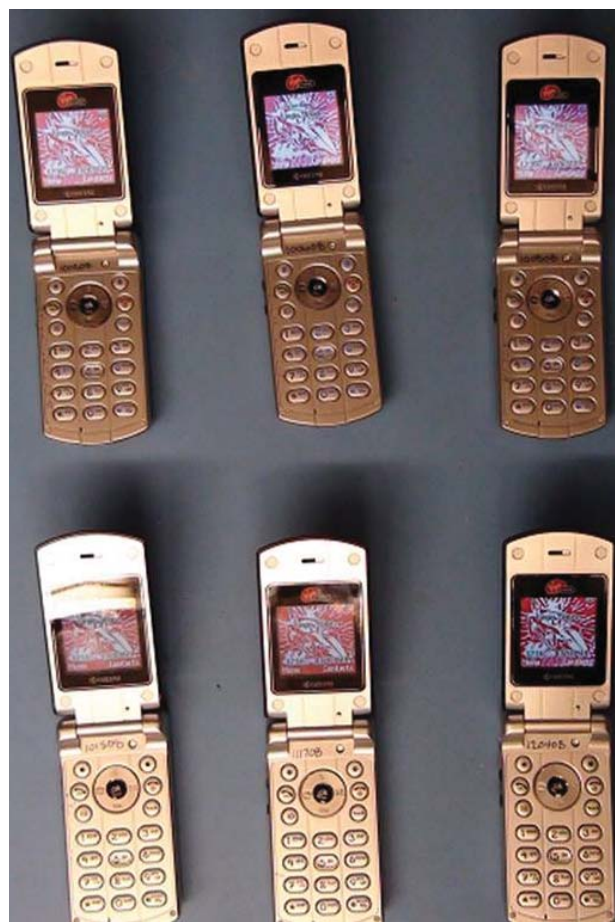
Figure 4-4. Cell phones powered on 12 months after exposure.

Figure 4-4 shows the cell phones, powered on, one year following HPV fumigation. During the 12-month observation period, no visual changes were noted. None of the cell phone screens indicated any signs of dimming of the back light or detectable color alterations.

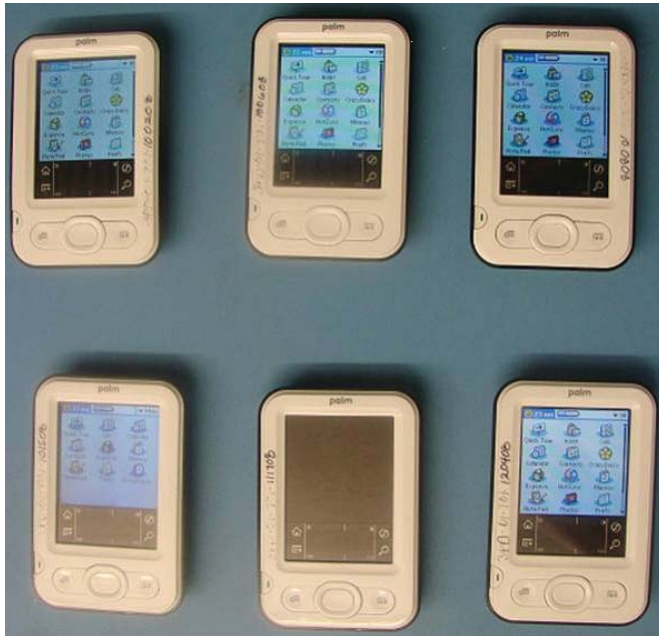
Figure 4-5. PDAs powered on 12 months after exposure.

With the exception of the PDA from test run R05, Figure 4-5 shows that the screens from the remaining PDAs maintained their pre-exposure physical appearance. The R05 PDA failed to power on, and an examination of the screen appearance could not be performed. The outer casing of all PDAs appeared unchanged. An internal physical evaluation of the PDAs was not possible without damaging the device.

The PDA that would not power on (R05) was the low concentration STERIS VHP run (250 ppm-hr CT). The high concentration STERIS VHP run (test run R06 at 1000 ppm-hr CT, shown in the bottom right of Figure 4-5) powered on normally and had no indication of change in the screen's physical appearance. This observation indicates that the failure of R05 may not be related to the HPV exposure, but that R05 was a flawed PDA that would have failed under normal use. Because this failure to power on was the only effect seen in any of these items, these results indicate that Category 3 materials are compatible from a visual impact standpoint with both the BioQuell HPV and STERIS VHP fumigations performed in this study.

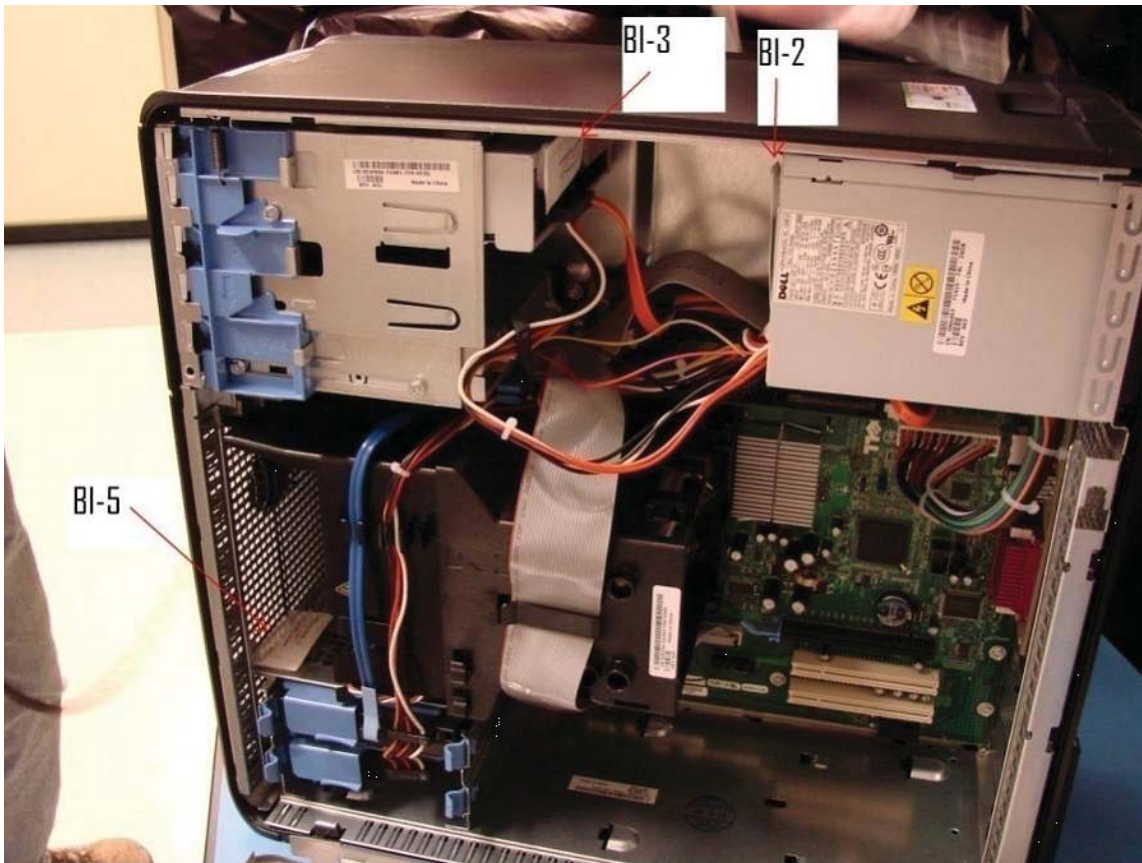
Figure 6-2. Location of the remaining three BIs in both high and low air flow locations inside the computer.

Figures 6-1 and 6-2 show the locations of the BIs within each computer. These locations were chosen based on the available mounting surfaces that afforded relatively unrestricted air flow. Two BIs were placed on the side cover (Figure 6-1) in areas of high air flow. Three more BIs (Figure 6-2) were placed inside the computer to capture both high and low air flow locations. BIs were also present in the MEC chamber, one on top of each Category 4 computer case and two between the keyboards and monitors on the top shelf of the MEC chamber.
