Could Zinc Whiskers
Be Impacting
Your Electronics?

Raise Your Awareness

Jay Brusse

QSS Group, Inc. @ NASA Goddard Space Flight Center

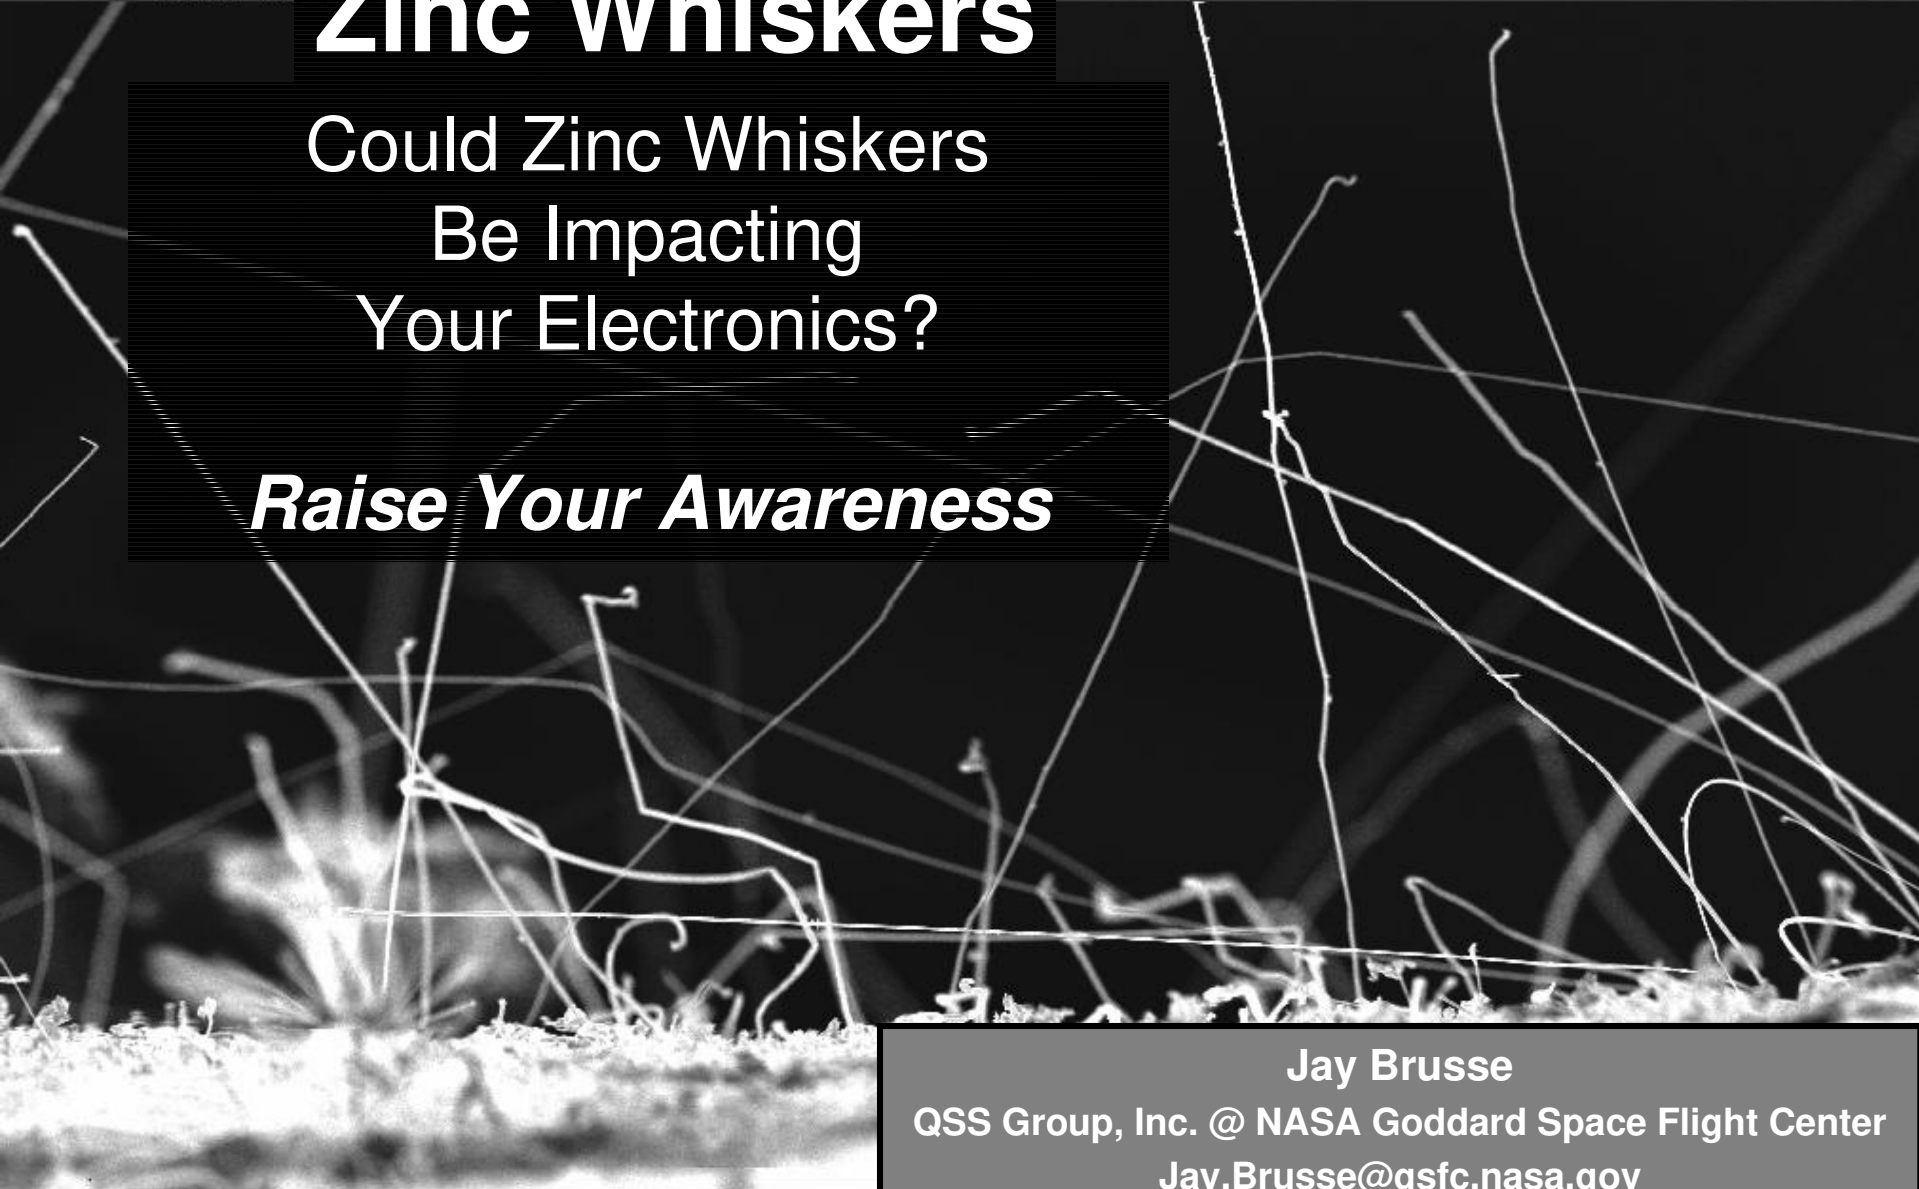
PHOTO= 15

ZINC WHISKERS

Zinc whiskers are tiny conductive filaments of zinc typically less than a **few millimeters (mm) long** and only a few thousandths of a millimeter in diameter. They grow from metal surfaces (e.g., steel) that have been electroplated (galvanized) with zinc for corrosion protection. The growth process consists of an **unpredictable incubation period** (months or perhaps even years) followed by a period of growth at rates **as high as 1 mm/year**.

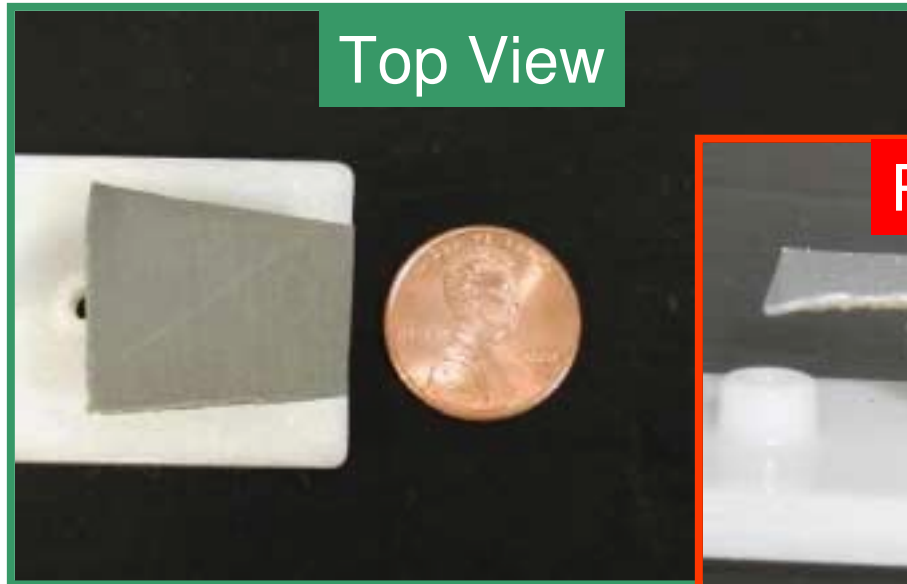
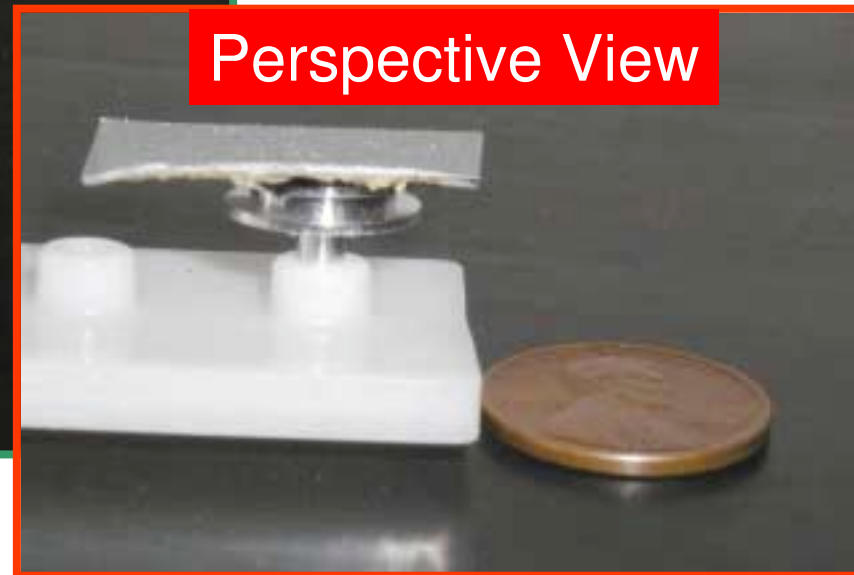
Zinc-Plated Steel Removed from Access Floor Tile

Sample Has Been Mounted to an Aluminum Stage Using Double-Sided Conductive Tape to Facilitate Optical and Scanning Electron Microscope Inspection

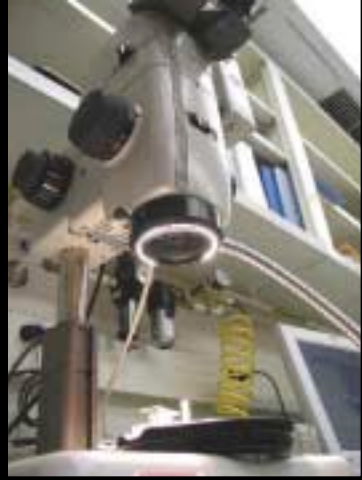
Microscope w/
“Ring” Light for
Top Illumination

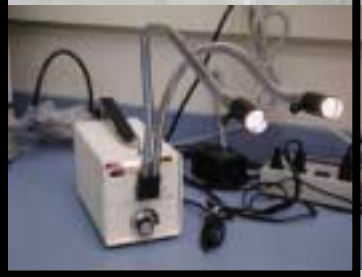
Side Illumination
Via “Flex” Light

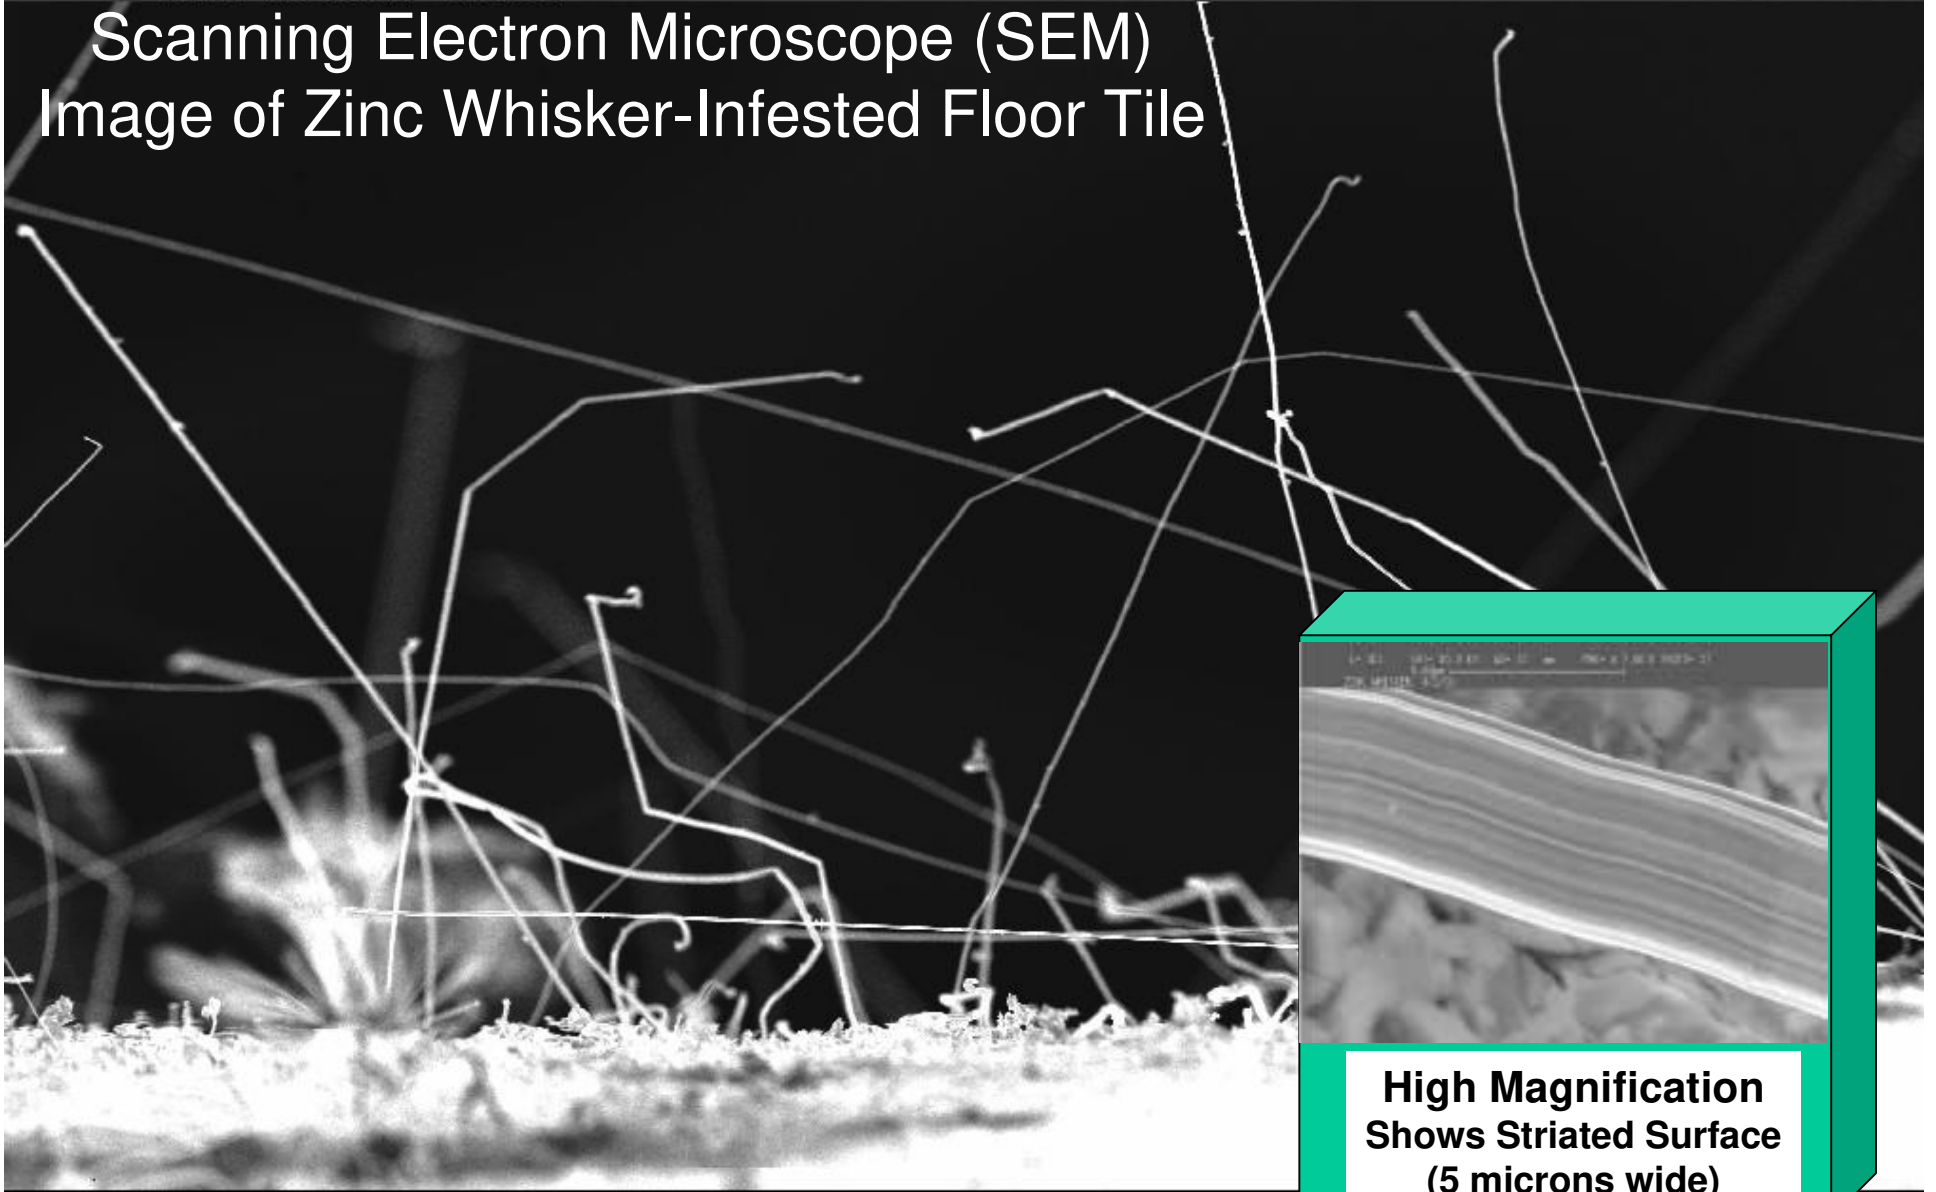
Scanning Electron Microscope (SEM) Image of Zinc Whisker-Infested Floor Tile

200 μ m |-----|

ZINC WHISKER, 4/1/03

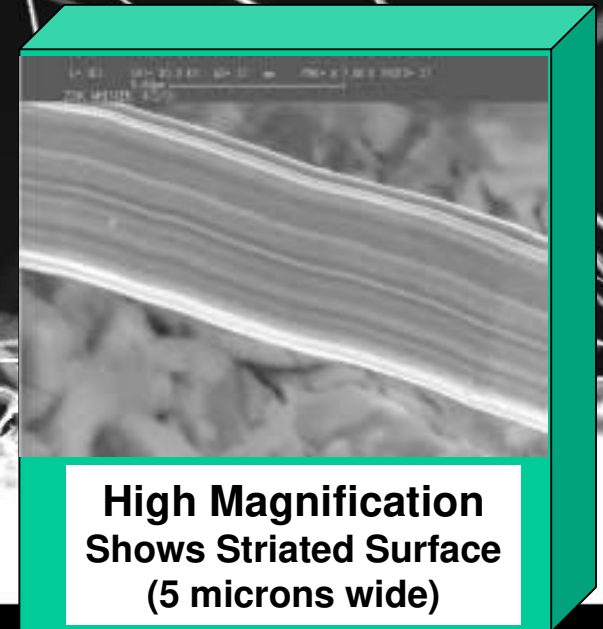
High Magnification Shows Striated Surface (5 microns wide)

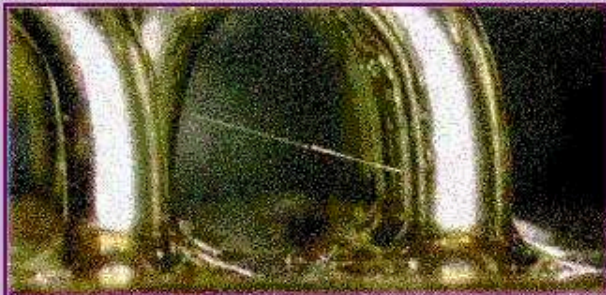
Tin Whisker Growing from Pure Tin Plated Relay Terminal
